**Report No. UT-05.06**

**CONCRETE BRIDGE DECK  
MANAGEMENT PRACTICES:  
SUMMARY OF SCANNING TOUR**

**Final Report**

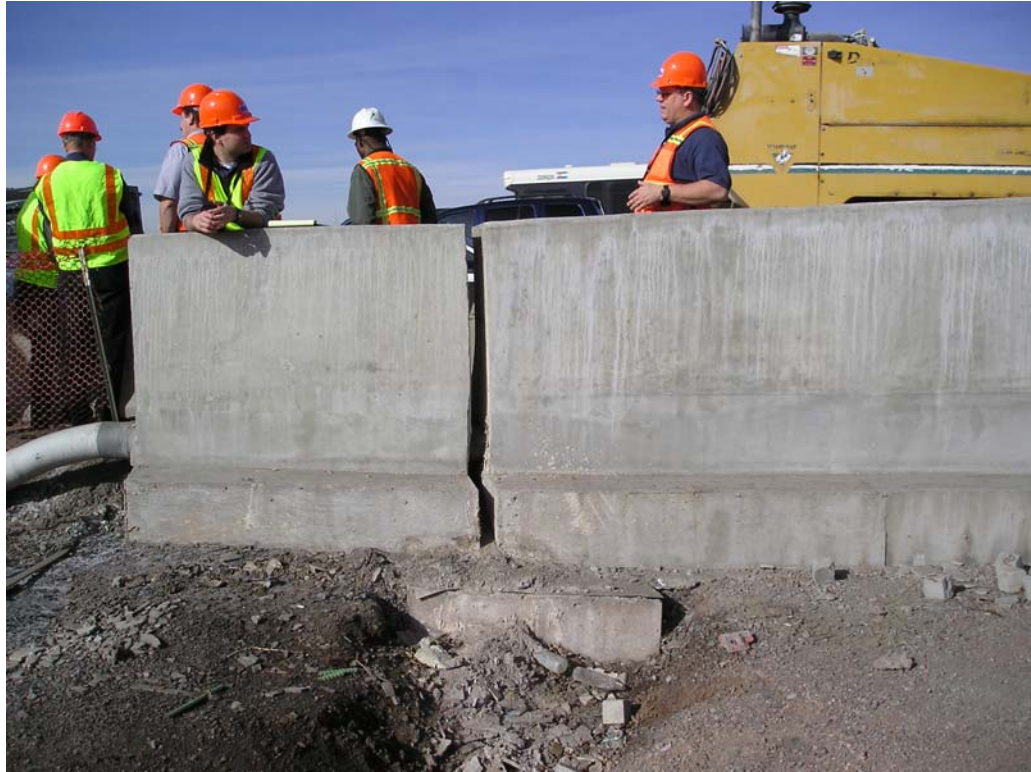
**FIGURE 2.45** Sleeper slab on CDOT bridge in TREN project.

mainly with concrete is cost efficient. Nonetheless, asphalt membranes are being placed with a 2.5-in. stone matrix asphalt overlay on new decks in the Transportation Expansion (TREN) Project. Sleeper slabs are also being incorporated in the TREN project as shown in Figure 2.45.
